MODEL
Rio (UB)
2012-2013MY

NUMBER
PS244

SUBJECT: MOISTURE PRESENT ON PASSENGER SIDE FLOOR

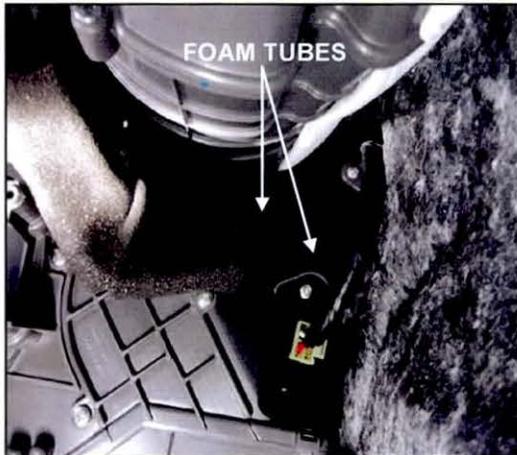
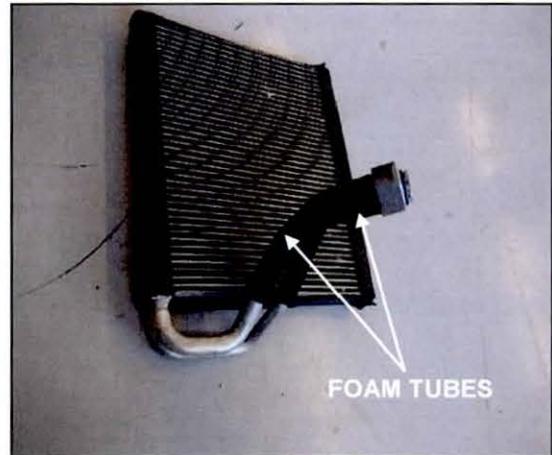
If you encounter a customer complaint relating to moisture being present on the passenger side floor, check the evaporator lines as a possible source for the moisture. On some 2012-2013MY Rio vehicles, the evaporator lines may have been insulated with foam tubes that may not be adhering properly to the evaporator lines and allowing for an air gap to form. This may cause condensation to form on the lines which may then find its way onto the passenger floor. Remove the evaporator and all insulation from the pipes. Locally source and apply new foam insulation tape to the lines, making sure to completely wrap the lines from the evaporator core to the expansion valve, in order to prevent condensation from reoccurring.
